Design, Construction, and Operation of a Field Demonstration for In Situ Biodegradation of Vadose Zone Soils Contaminated with High Explosives

Ken Rainwater, Justin Brown, Caryl Heintz,
Tony Mollhagen, and Lance D. Hansen

September 2001

Final report

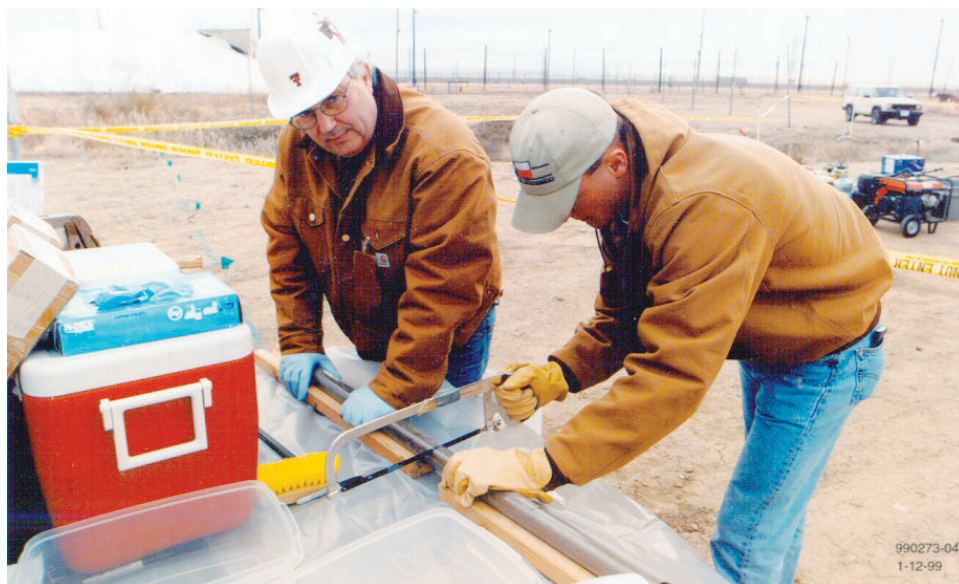
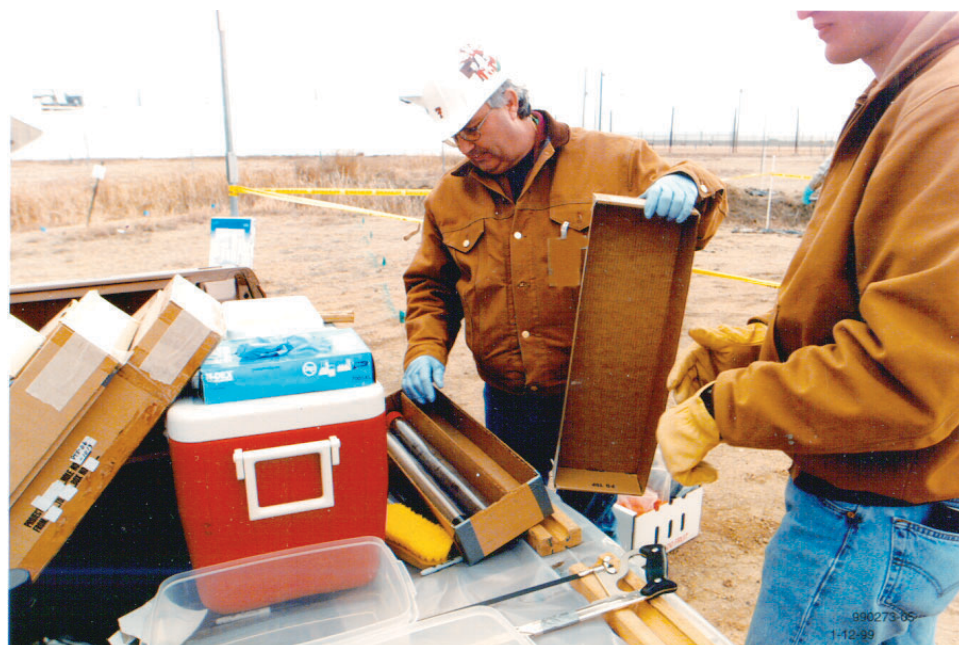
Figure 6. Preparing and handling of soil cores

As the holes were bored, 4-ft core samples were collected in clean plastic liners from the geoprobe rig. The ends of each section were sealed with rubber end caps to help maintain the original soil conditions. These samples were then cut into 2-ft sections using a sterile hacksaw blade and placed into core boxes to prevent direct contact with sunlight. Preparation and handling of core samples can be seen in Figure 6.

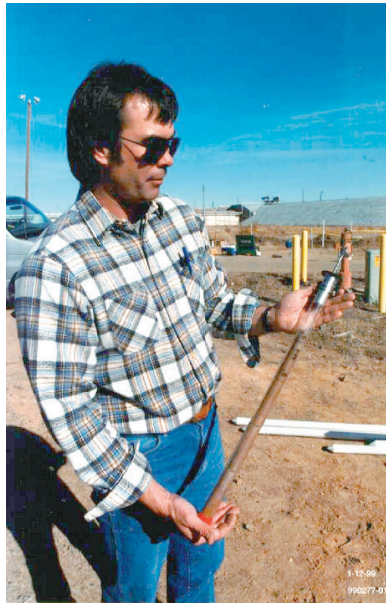
Figure 9. SPIES well and tube assembly

The strategically placed intermittent environmental samplers (SPIES) were used to monitor the amount of HE degradation occurring in the treatment zone. The SPIES soil samples were removed from the actual field site using a geoprobe rig, and the initial HE concentrations were determined for each end of the soil sample. Each soil sample was initially 2 ft long with a diameter of 1 in. The SPIES soil samples were each housed in a plastic tube that had 0.125-in.-diam holes drilled 1 in. apart on centers at 90, 180, 270, and 0 deg to allow adequate movement of gas into the soil

sample. The SPIES wells (shown as “S” in Figure 7) were constructed to have soil sample depths of 8, 15, or 25 ft (depth noted on Figure 7). The six SPIES wells were cased using 2.5-in. PVC pipe with screened sections in the bottom 2.5 ft of the well. The screened section of each well was sand-packed, and bentonite chips were used just above the screened section. A 0.25-in. copper tube was installed from the middle of the screened section to the manhole to monitor the composition of gasses in the well. A diagram of a SPIES well and picture of the SPIES tube assembly can be seen in Figure 9. The surface completions were the same as the injection and extraction wells.

Each soil sample was suspended in 2.5-in.-diam PVC screen by braided wire attached to the well cap. The SPIES soil samples were removed from their respective wells once a month for collection of a 15- to 20-g sample from each end of the soil core. The soil samples were then analyzed (using the method described in Chapter 3) for HE concentration to determine the amount of degradation occurring in the SPIES soil samples.

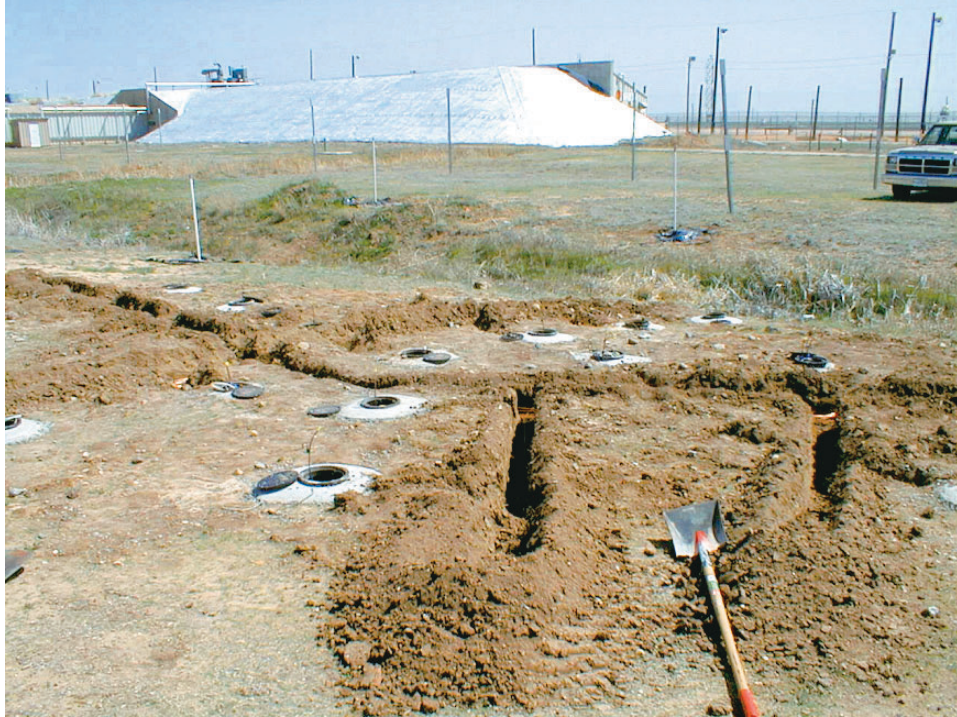
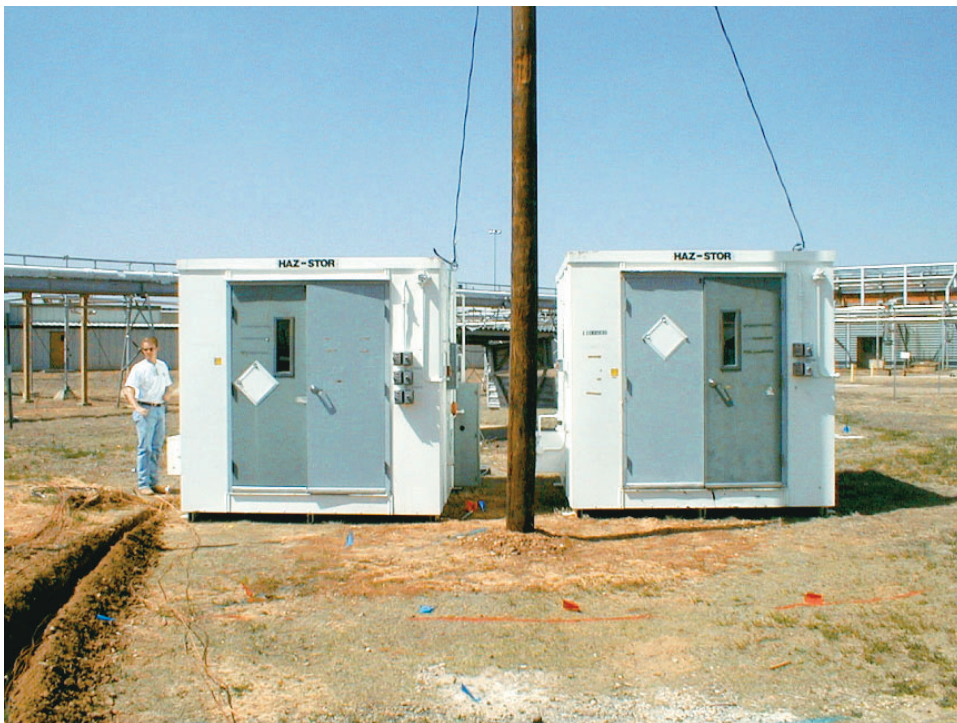
Figure 10. Installation of plumbing and control buildings

The 29 copper tubing lines were run from the finished field site to control buildings located approximately 150 ft southwest of the finished site. The tubing was buried approximately 11 in. below the ground surface to avoid any buried utility lines and to protect against freezing and inadvertent damage. Where the copper tubing crossed the road, the tubes were placed in three separate bundles and run through 2.5-in.-diam steel pipes to prevent the weight of passing vehicles from crushing the copper tubes. For aesthetic purposes, the copper tubes were then run through an 8-in. PVC pipe before entering the south wall of the control building. Photographs of

the plumbing work and control buildings can be seen in Figure 10. The two 10-ft by 10-ft control buildings were placed approximately 150 ft southwest of the field well site. One control building housed most of the plumbing work, valves, flow meters, and extraction pumps. The other control building housed the liquid nitrogen cylinder, water column, and gas-monitoring devices.
